Date: 05/2015	<p align="center">FIGURE 1 OVERVIEW MAP</p> <p align="center">Seaford Town Gas Site (DE-0069) Conceptual Site Model & Sampling Analysis Plan</p> <p align="center">SEAFORD~SUSSEX COUNTY~DELAWARE</p>	DESIGNED BY: JCR

A Preliminary Assessment

Seaford Town Gas Site (DE-0061)

Facility Evaluation Report

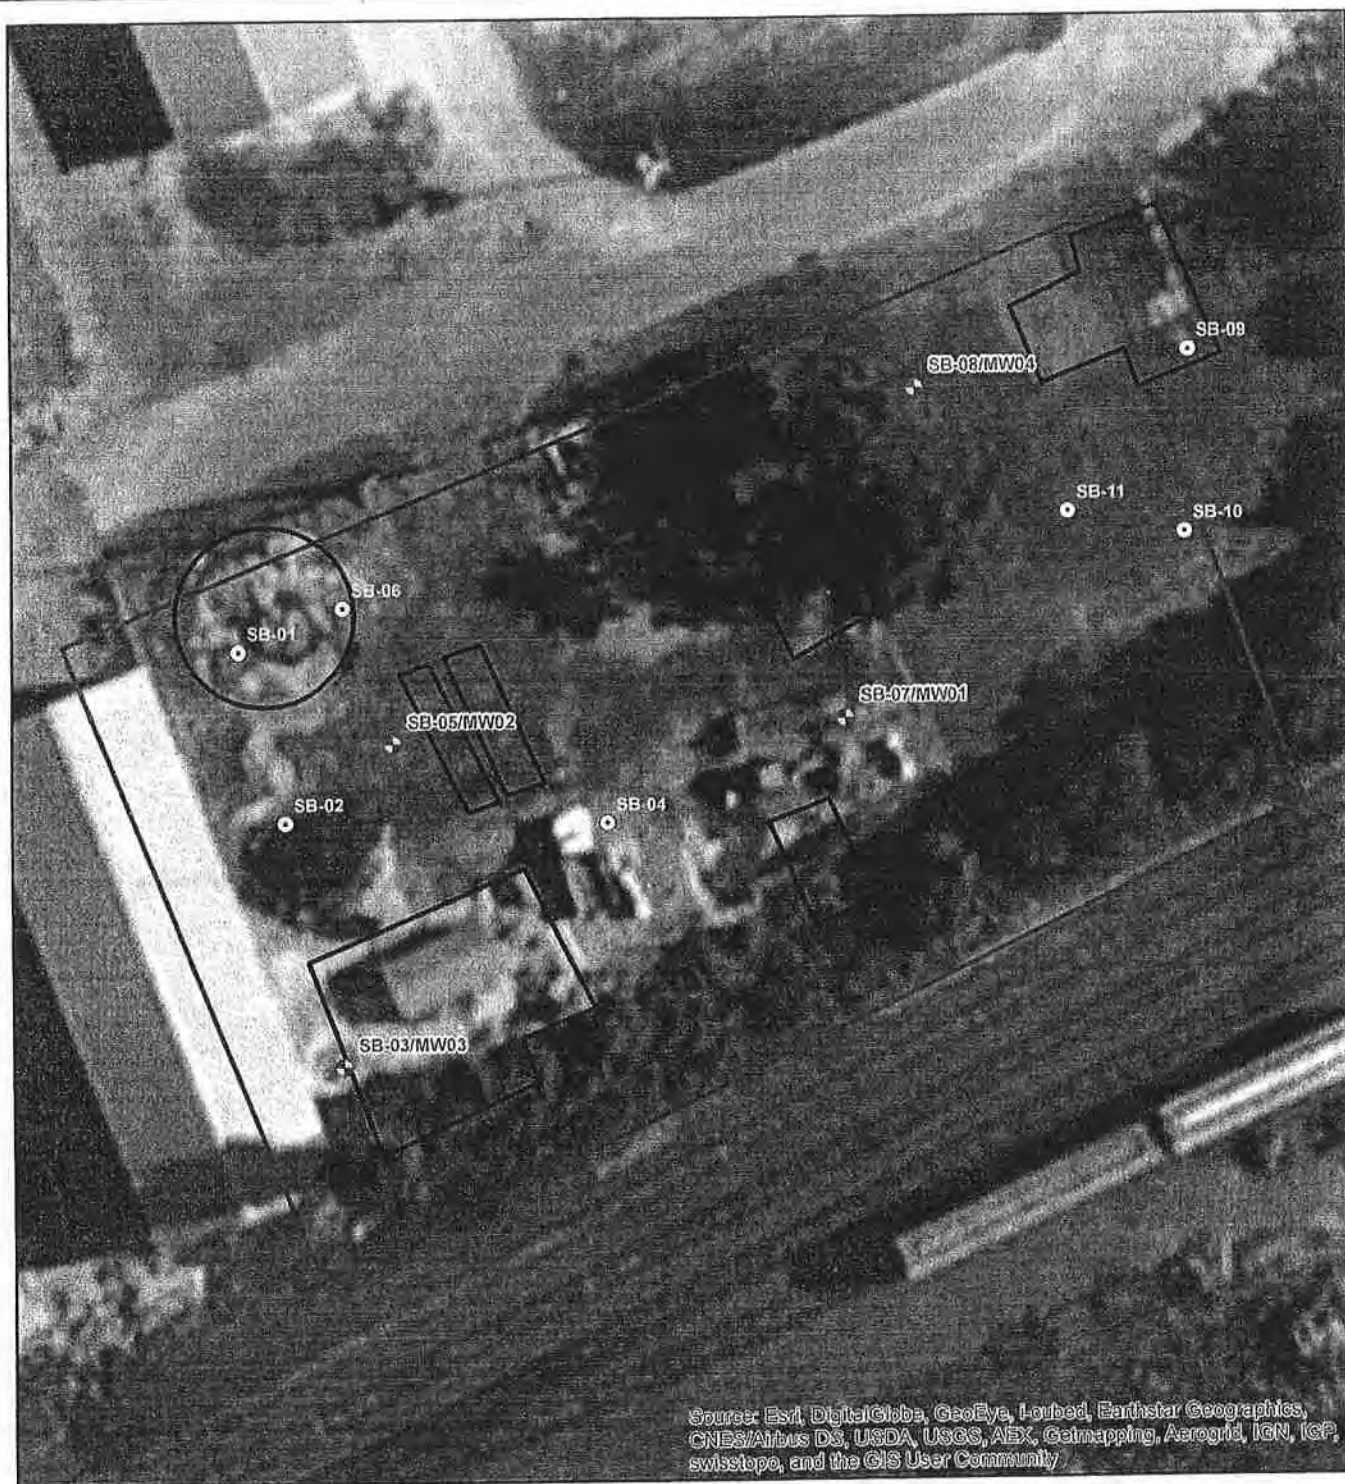
S:\00-Proposed\State & Local\DE-CNREC\1\08\627\AS - Seaford Gas\3. Working Files\Figures\Figure 3 - Boring Locations.mxd

Tetra Tech contracted Vironex to provide a Delaware-licensed well driller and a truck-mounted Geoprobe drill rig to advance soil borings, collect soil samples, and install and develop monitoring wells. The drilling and well installation was conducted between November 19 and 20, 2014. A total of eleven soil borings were advanced and four monitoring wells installed at the site. The boring and well locations are depicted on **Figure 3**.

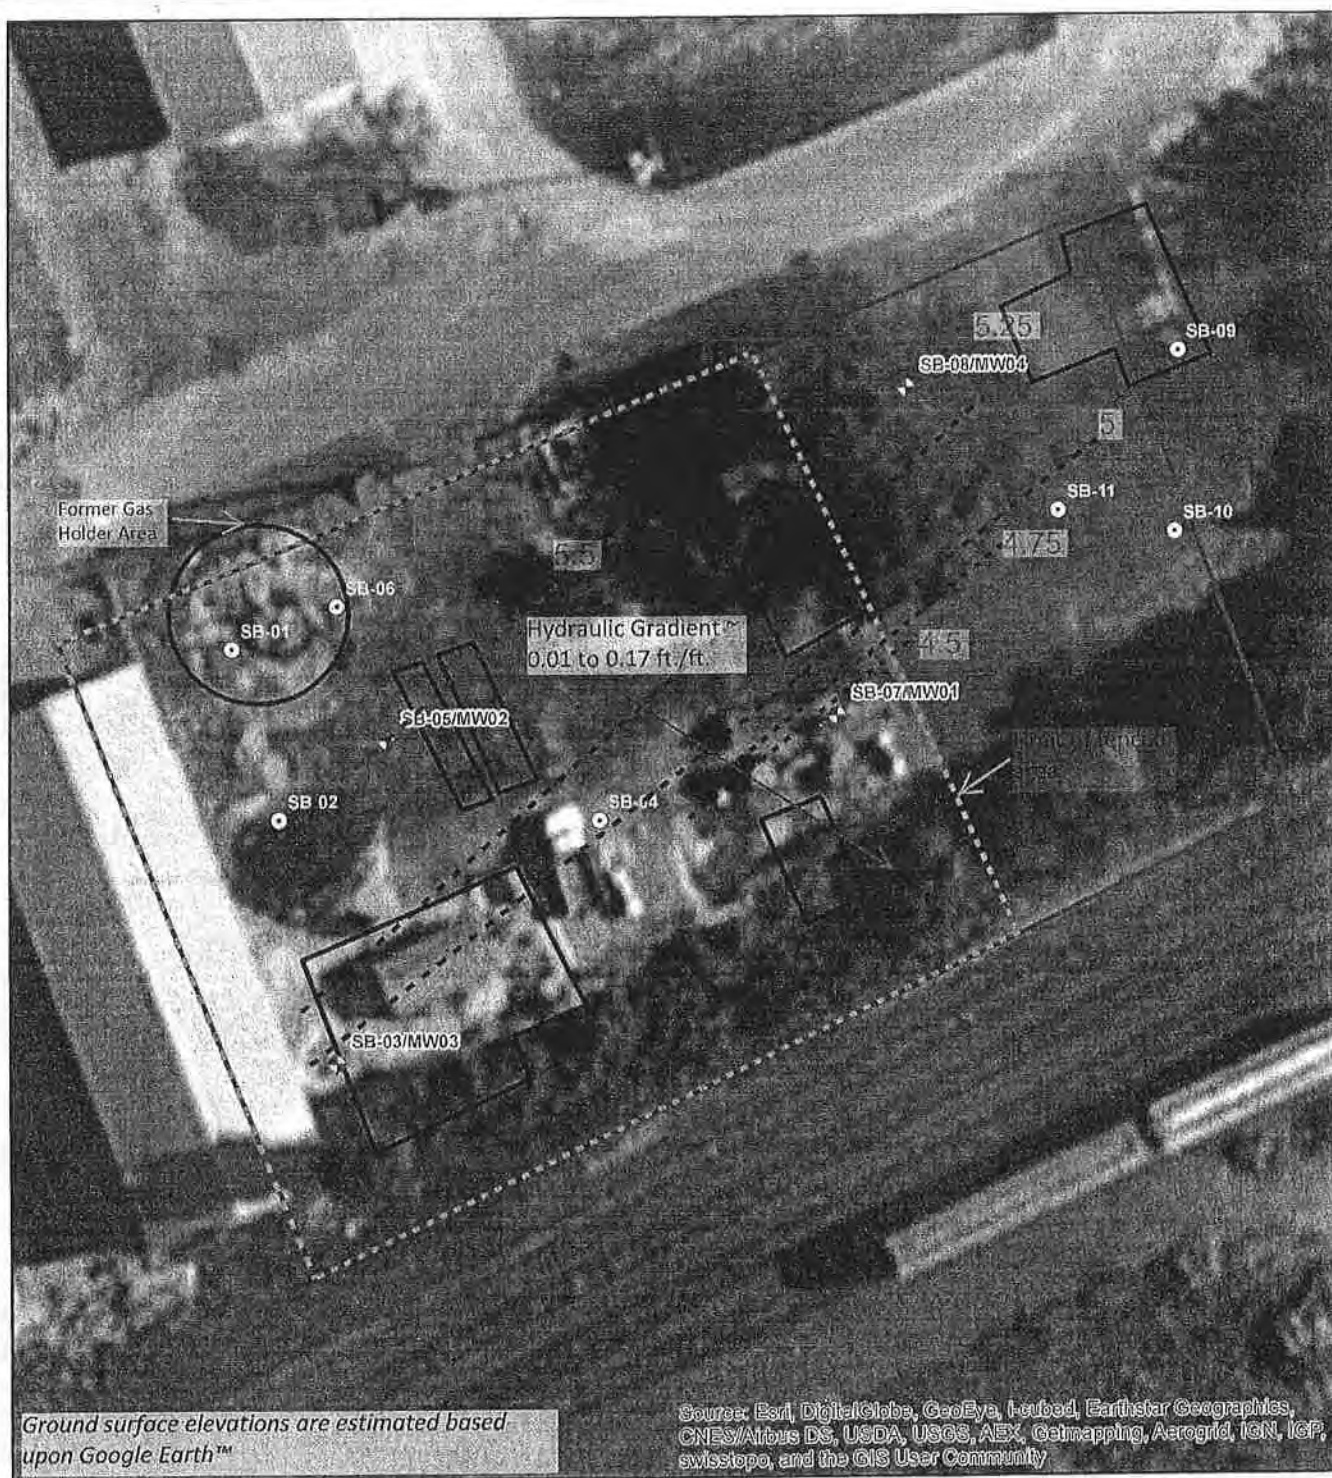
Water levels were measured at each well prior to conducting groundwater sampling. A summary of the water table elevation are provided in **Table 1**. A groundwater contour plan was compiled based on these water table elevations and is presented as **Figure 4**. The contour plan indicates that the apparent groundwater flow is to the southeast toward the Nanticoke River with an approximate flow gradient ranging from 0.01 to 0.017 ft./ft. It should be noted that the gradient and flow contours are based upon a limited number of points (four).

- GW Flow Direction (Inferred)
- Soil Boring
- ⊕ Soil Boring Converted to Well
- Approximate Historical Structure Locations
- Property Boundary
- - - Limit of Fenced Area
- GW Elevation Contour Line (dash where inferred) - Ft. MSL
